Request for Proposals  
THOMAS POND DAM REPAIRS

The Thomas Pond Dam (Dam) is located on the Casco Raymond line and controls the water flow from Thomas Pond/Dingley Brook into Sebago Lake. It is located near the intersection of Hawthorn Rd. and Raymond Cape Rd. The Dam is listed in the national Inventory of Dams as NID: ME00073<sup>1</sup> and by Maine as MIDAS number 3392. Thomas Pond is currently estimated to be 533 acres in size with an average depth of 22', containing roughly 10,500 acre-feet of water<sup>2</sup>.

The Dam was (re)built in 1935 and substantially repaired circa 1991 by Bancroft Contracting. Over the 33 years since the last repair the Dam has developed some cracks and portions of the concrete show damage from erosion. This damage is mostly in the spillway area of the Dam. The wing walls appear to be in good condition.

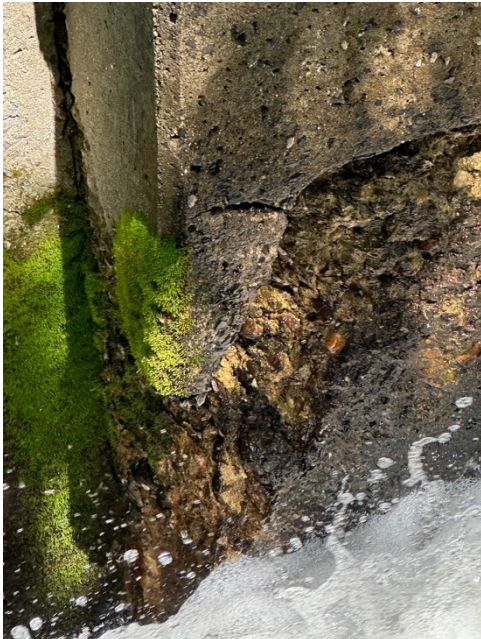
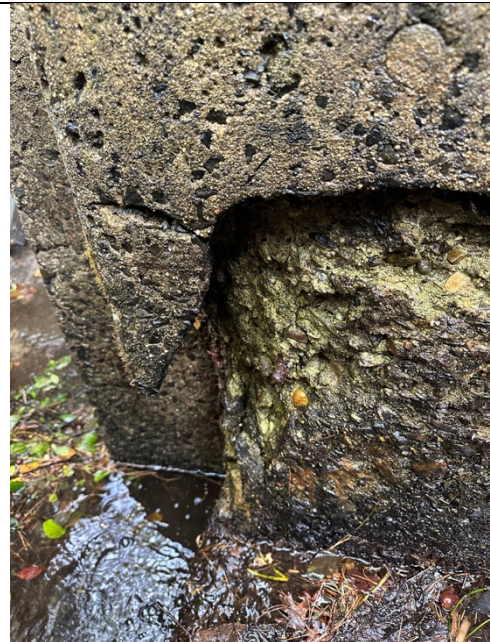
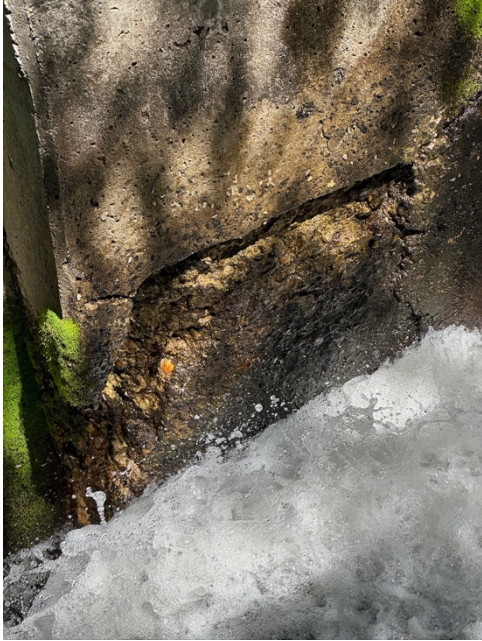
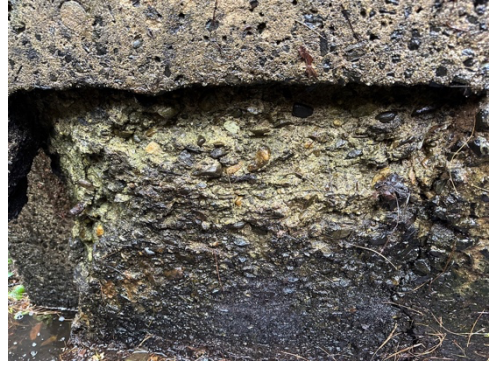
#### A.

Damaged corner of the Dam and associated cracks, at the bottom of the spillway on the abutment on the Casco side of the Dam.

Not easily visible, but there is about a 1'x1'x6"D "hole" right below the damaged area. While we aren't sure, it appears this may be an intentional feature of the dam since the sides appear even.

The Casco side is the area of greatest visible damage. The associated crack appears to run back to inside the stop log holder and the void was large enough to put a hand into before we put in hydraulic cement. There is continuous seepage through this crack.

For seeping cracks and gaps responses must include filling any voids behind the concrete surface and the method that will be used to do this (e.g., filling with cement or mortar, polyurethane injection, or other). TPIA anticipates this will require removal of temporary hydraulic cement patches applied by TPIA in an effort to prevent further deterioration until the work can be completed professionally.

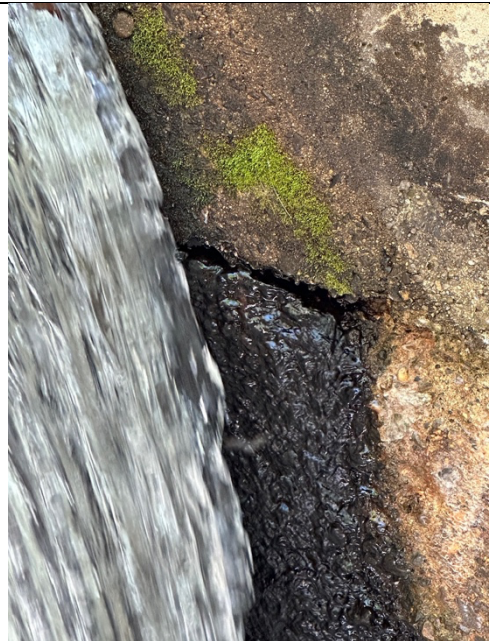
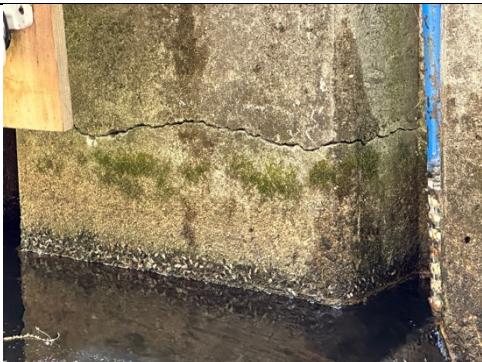
**B.**  
Crack with seepage near stop logs on the Raymond side of dam

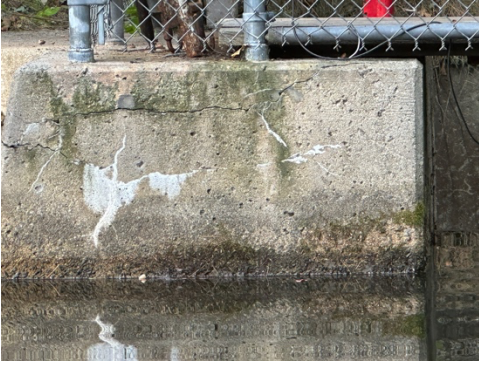
**C.**  
Dry crack in the Dam between the two stop log slots on the Raymond side. Less than 2' from the top of the dam

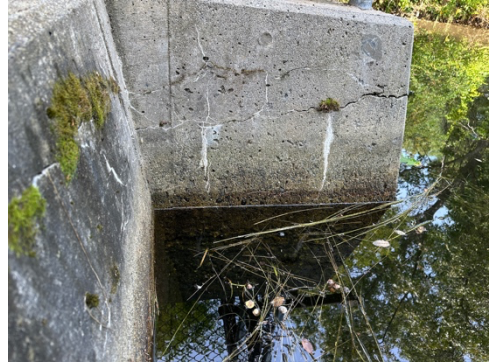
**D.**

Dry cracks in Raymond side of Dam abutment facing Dingley Brook. No similar cracks observed on Casco side.

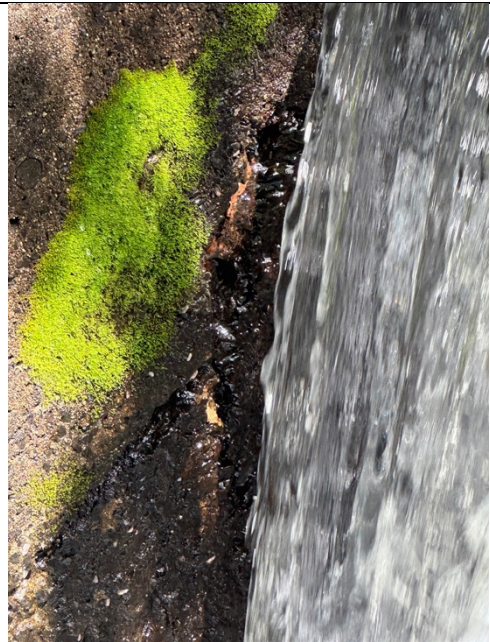
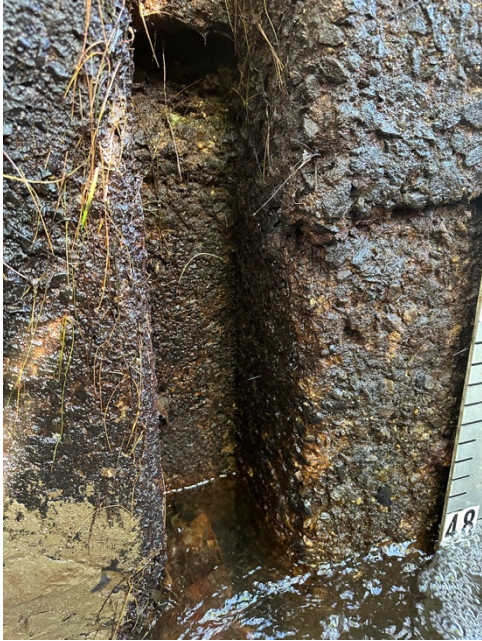
**E.**

More concrete damage and seepage on the abutments. This closeup is on the Casco side. The concrete damage mostly appears to be surface erosion. Both the Casco and Raymond sides have this type of wear near areas where the water flows over the stop logs.

The Raymond side (photo on website) shows little erosion in the stop log cut-out.

Repairs to the downstream Casco-side stop log cut-out shall not reduce the width or depth of the cut-out.

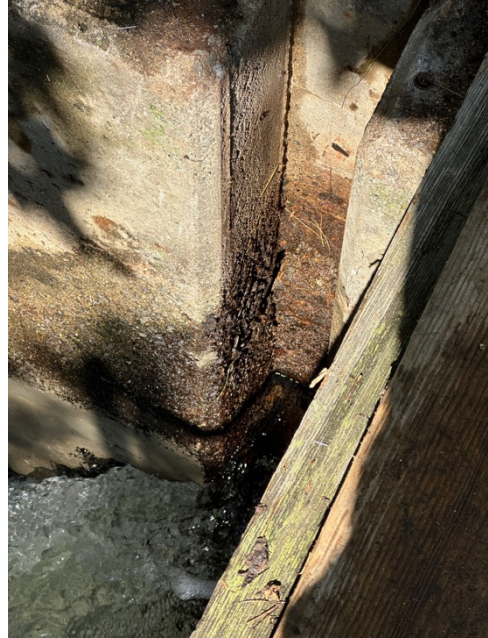
**F.**

Concrete degradation at the back of the stop log cut-out on the Casco side. (both photos) The hydraulic cement patch is visible to the lower left in the photo.

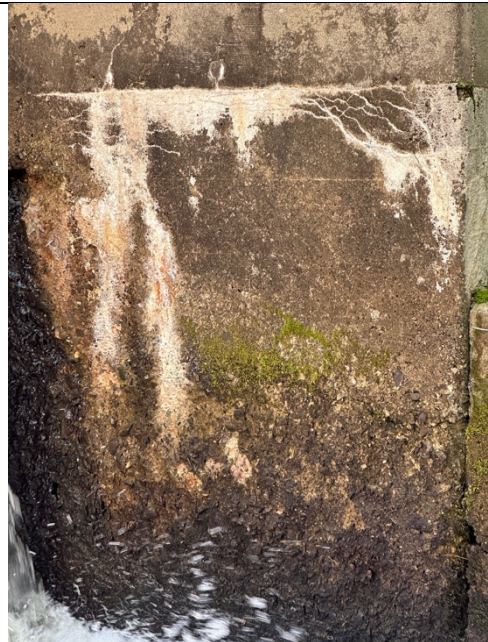
**G.**

Wear, crack/seam and efflorescence on the Dam surface on the Raymond abutment.

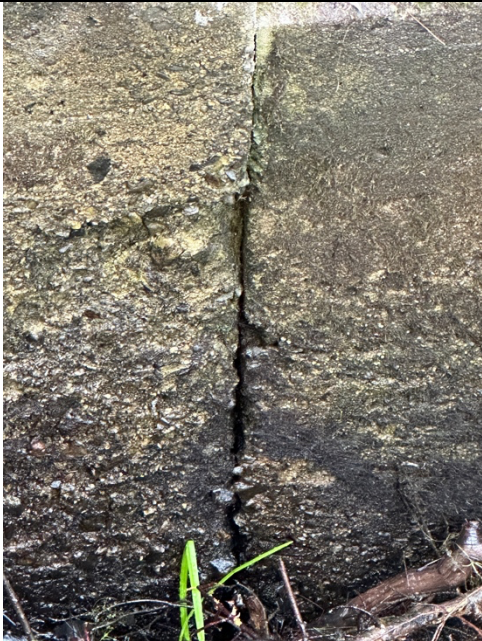
**H.**

Unpatched vertical crack on the Raymond side by the stilling basin (same crack as above picture) leading up to the ledge. Appears to be where two concrete forms met.

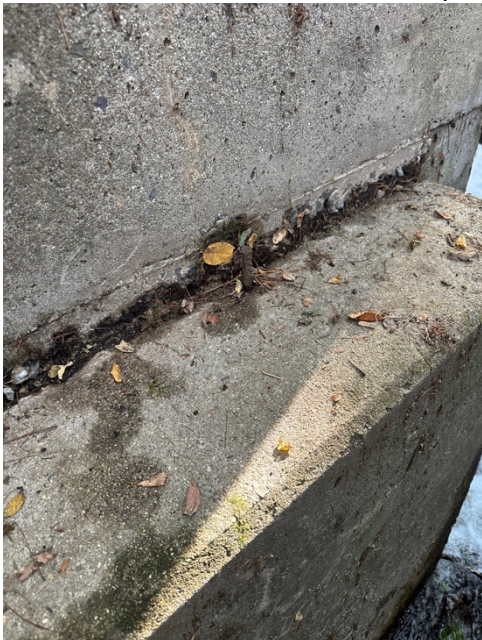
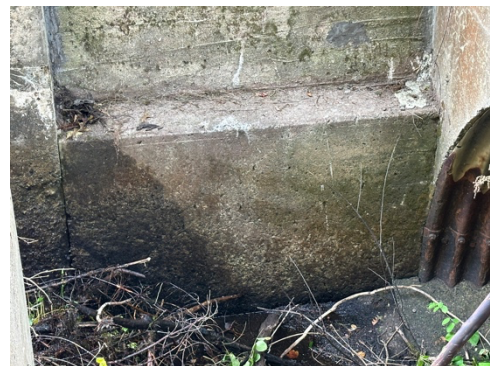
**I.**

Rough concrete surface on Raymond (right) and wear around the ledge Casco (below) abutments in the stilling basin area.

Also one exposed piece of rebar – is that an issue that also needs to be addressed for safety reasons?

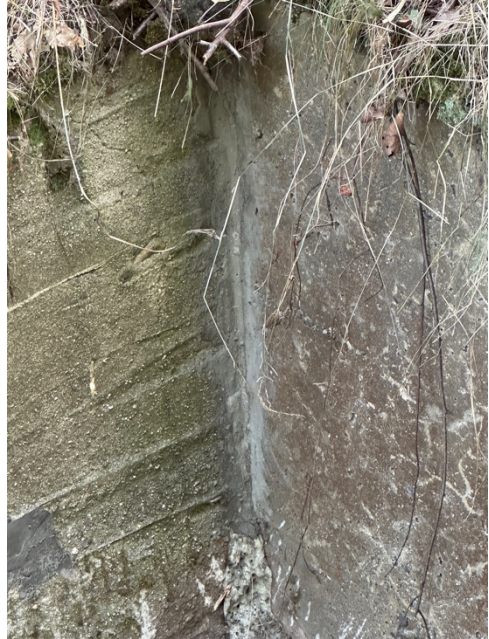
**J.**

Vertical crack, less than 1" in width, on the Raymond side abutment where it meets the support structure for the road and culvert (the downstream side of the stilling basin), patched with hydraulic cement. Well above water level.

No pre-patch photo is available.

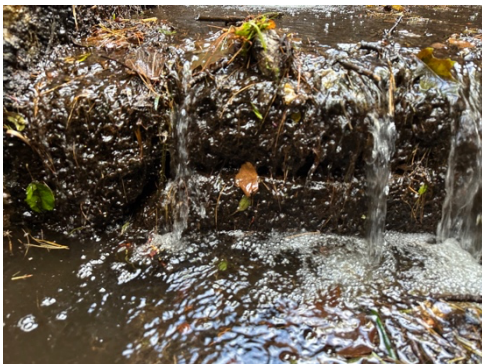
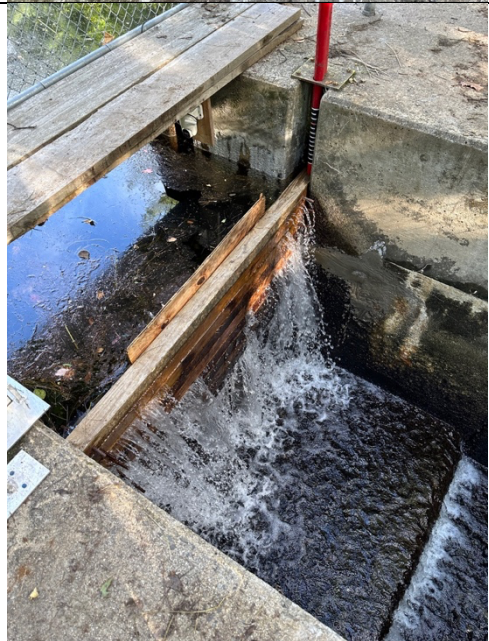
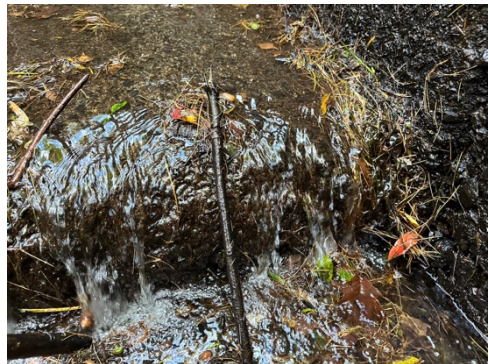
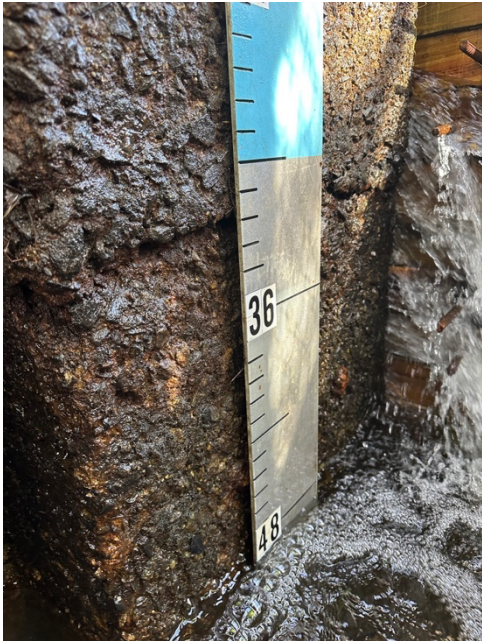
**K.**

Floor of spillway area of Dam. The "step" shown here is 15" high x 6' wide x ~5' long. The surface where the water hits is worn rough, but appears to be free of cracks.

There is some erosion on the Casco side near the corner (below) but not on the Raymond side (bottom right photo).

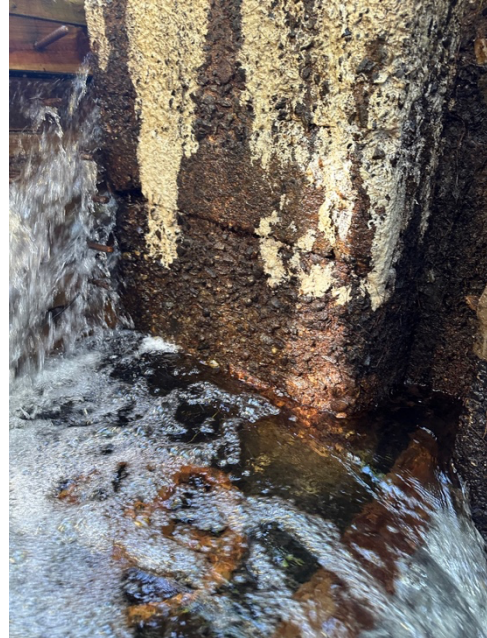
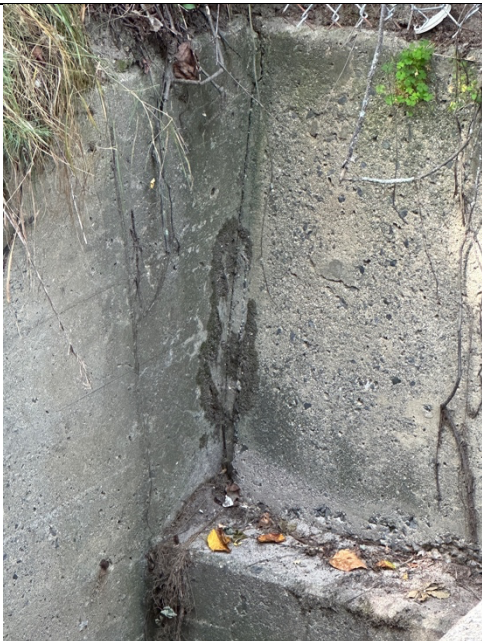
**L.**

Cracks about 32" below the top of the dam on both the Casco (left) and Raymond (right) sides of the dam in the area between the two stop log holder cut-outs.
